A FIVE-YEAR REVIEW OF THE CANADA-ONTARIO-INDUSTRY ROCKBURST PROJECT

SP90 – 4E

D.G.F. Hedley
Mining Research Laboratories

CANMET Special Report SP90-4E

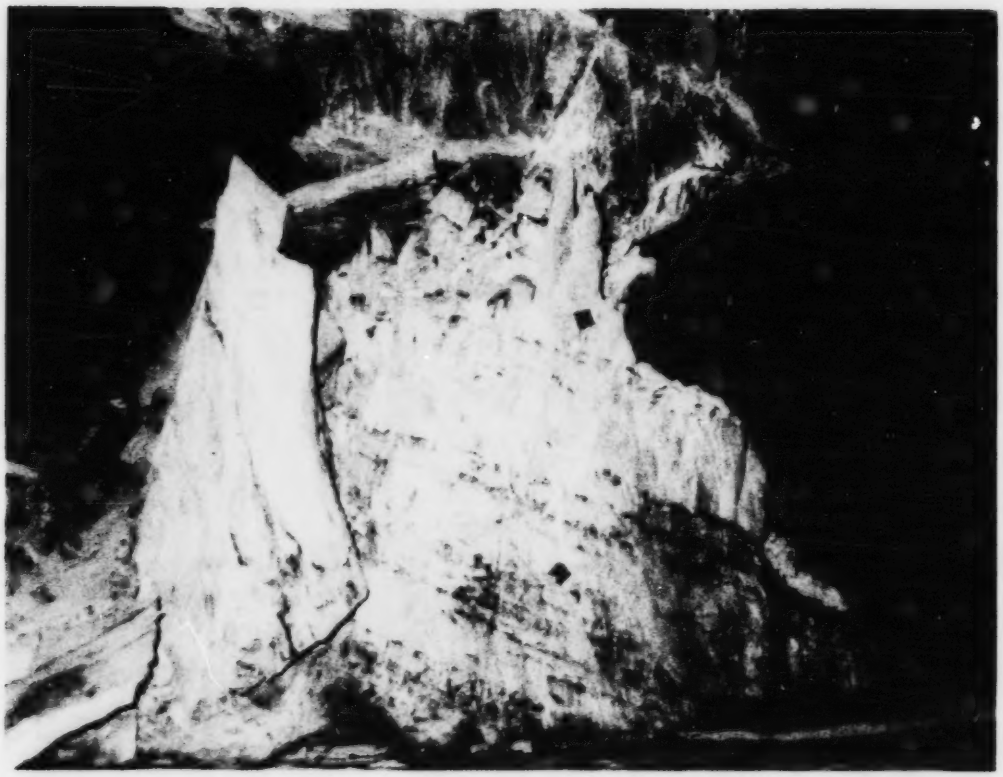
Damage to a sill drift at the Quirke Mine.

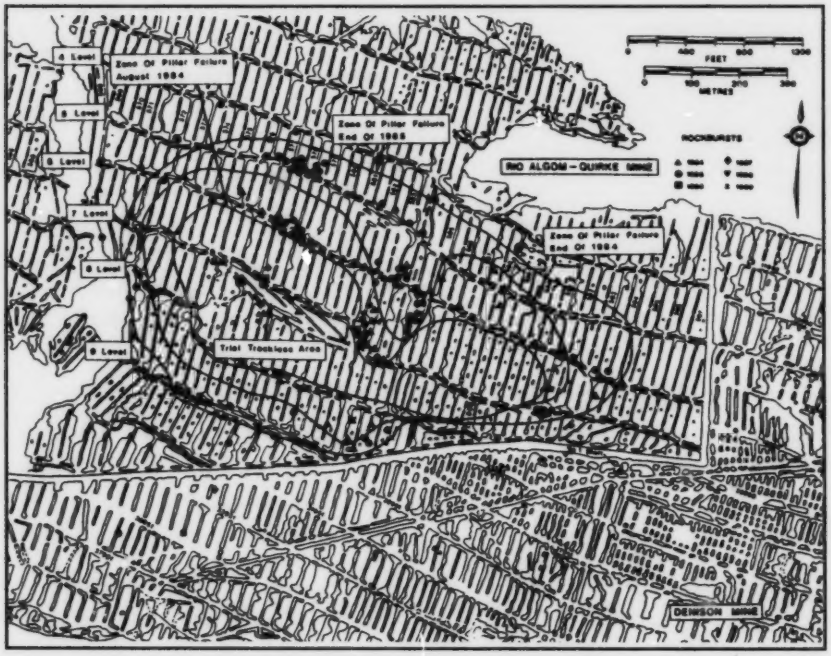
Figure 12 - Plan of Quirke Mine showing rockburst locations, 1984 to 1989

The rockburst incidents at Quirke Mine are a classic example of a chain reaction of pillar failures. Over a five-year period, more than 160 seismic events, up to magnitude 3.5, were recorded by the Eastern Canada Seismic Network. An area over 70 ha was affected underground.

A plan of the eastern part of the main reef at Quirke Mine showing the locations of the rockbursts is illustrated in Figure 12. The rockburst problem began in 1982, next to a trial trackless area. There was a major increase in activity and expansion of the rockburst area in late 1984 and early 1985. Two patterns of activity were observed. First, violent failure of the pillars occurred at the edge of the affected area, which allowed the area to expand. Second, a number of events occurred in the centre of the affected area, accompanied by a sudden increase in water flow of 1000 L/min into the mine and a drop of 4 m in the water level in a small lake directly above the area. The latter events probably occurred in the hanging wall and were caused by slippage along near-vertical faults or along bedding contacts. Since the hanging wall fractured through to surface, the level of microseismic activity has decreased substantially, as has the number and magnitude of the larger events. The affected area has stopped expanding and has essentially stabilized.

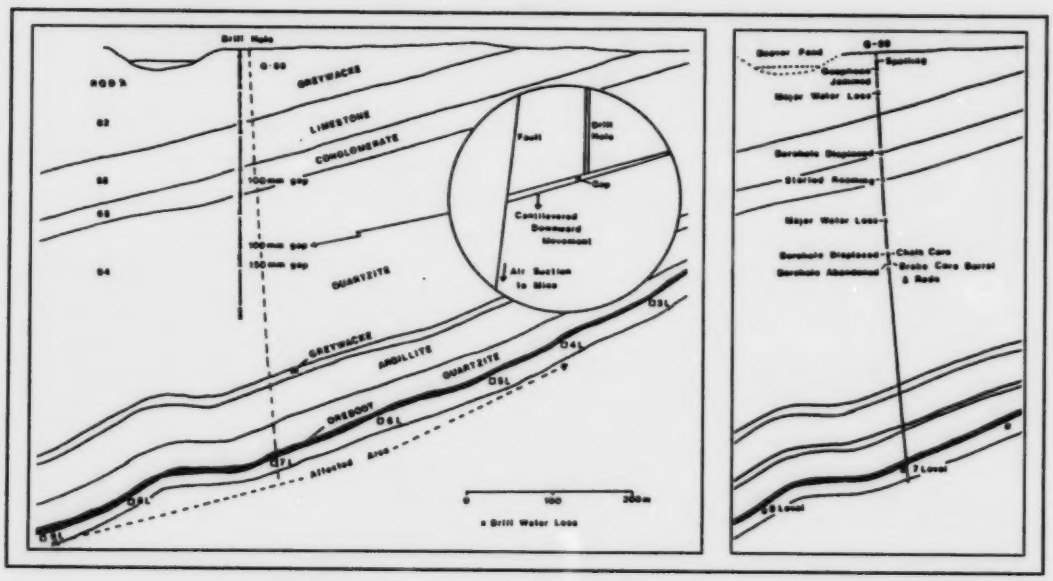
Figure 13 - Problems encountered during drilling of two boreholes above the rockburst area at Quirke Mine

Continuous loss of drilling water down the borehole occurred throughout the drilling operations. Also, it was found that the old borehole had been laterally displaced, due to slip along bedding contacts, at several locations. Eventually, the borehole had to be abandoned at a depth of 265 m, about 240 m above the orebody.

A new diamond drill hole, directly over the centre of the rockburst area, was drilled from surface in 1988. Drilling progressed to a depth of 317 m, about 170 m above the orebody, before the hole was abandoned because of water loss problems. Two types of open fractures were encountered. Down to a depth of 150 m, water circulation was lost at eight locations, which was attributed mainly to minor open fractures on bedding contacts. At a depth of 155 m, a 100 mm wide gap was encountered and air was being sucked down the borehole into the mine. Similar open gaps of 100 mm and 150 mm were encountered at depths of 234 m and 255 m. Figure 13 illustrates the problems that were encountered during the drilling of the two holes.

For water and air to flow down the borehole into the mine, vertical fractures must be present. It is postulated that caving is confined to the first few metres of the hanging wall. For the next 350 m, extremely large blocks or slabs have moved down along vertical faults in a cantilever fashion. The top 150 m has subsided without major vertical fractures.

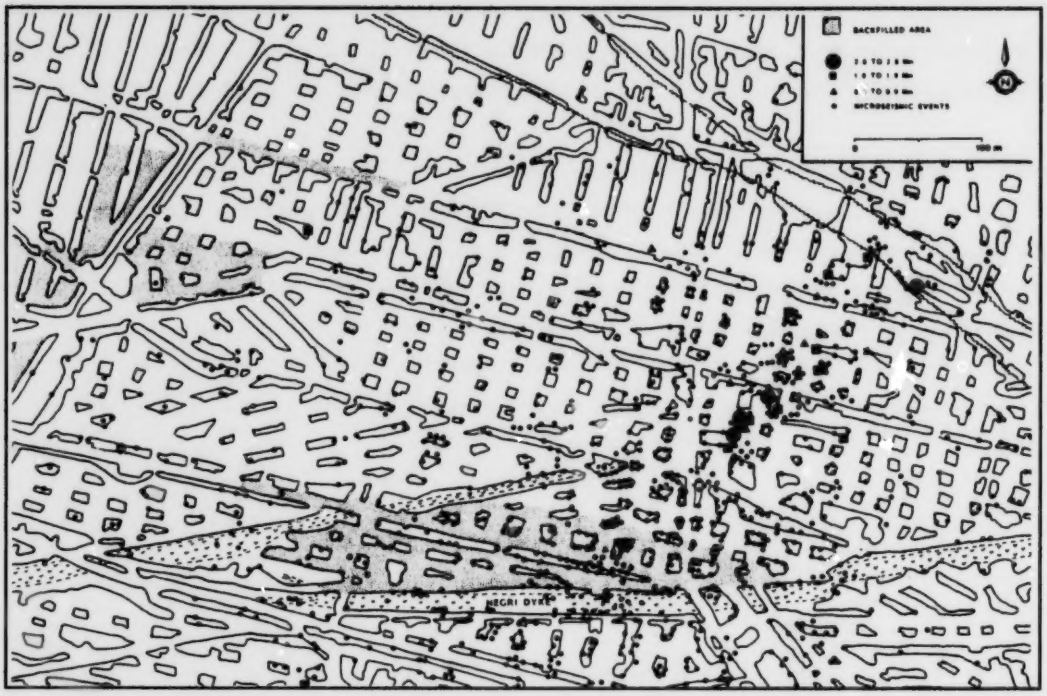
Figure 15 - Plan of the eastern part of Denison Mine showing extent of seismic activity, 1987 to 1989

Figure 15 shows the backfilled stopes and location of seismic activity, between 1987 and 1989, in the eastern area of Denison Mine. A number of large events of magnitudes up to 2.8 have occurred in a narrow band extending northeast to southwest across the area. Microseismic activity is more widespread, extending 800 m on strike by 500 m on dip, although, again, there is a concentration around the larger magnitude events. In this case, there is considerable microseismic activity in some pillars surrounded by backfill. This activity occurred mainly during the pour and is thought to be caused by the water reducing the rock strength on the edge of the pillars. However, once the pillars were encased in backfill, seismic activity in them essentially ceased. This type of behaviour was not observed in the boundary pillar area since the pillars there were larger and less stressed.

To contain the affected area shown in Figure 15, Denison Mine has begun to pour a 120 m wide backfill barrier in the stopes along the northwest boundary of the area.

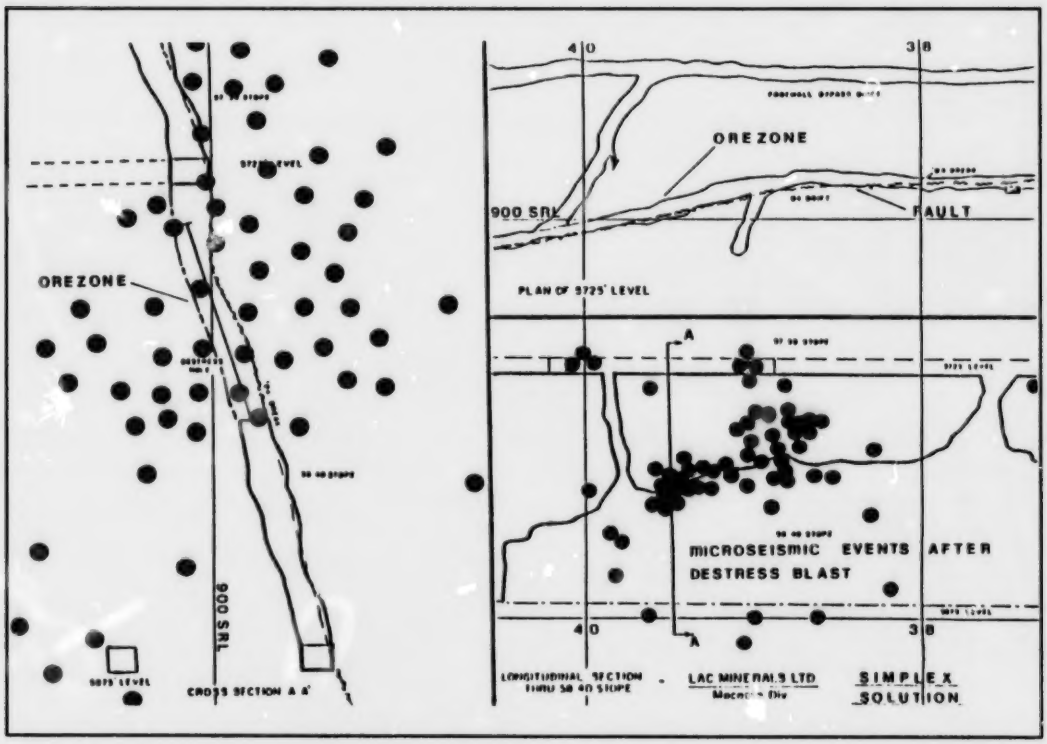
Figure 16 - Location of microseismic activity following a crown pillar destress blast at the Macassa Mine

Considerable microseismic activity, as shown in Figure 16, followed the blast and was clustered mainly around the crown pillar. However, some parts of the pillar were free of seismic activity, especially the pillar next to the first borehole by the east raise, which was not fully loaded. Significant convergence of about 25 mm also occurred in the stope except for only 6 mm next to the east raise. Subsequent mining of the crown pillar triggered a small rockburst at this raise causing damage to the timber stalls; the convergence in this area also increased to 33 mm. It was concluded that the initial convergence and microseismic activity was indicative of only partial destressing of the crown pillar.

About one year later, a series of rockbursts occurred after blasting in the crown pillar immediately above the destressed pillar. About 1000 tonnes of rock was displaced, and the drift adjacent to the destressed crown pillar also sustained damage. This drift was above a waste pillar that had not been destressed. In the final analysis, destressing of the crown pillar improved the recovery of the pillar itself but may have contributed to rockburst problems in the surrounding pillars.
